Important Information for Homeowners!

The Waukeee Fire Department would like to provide important information to Waukeee residents who have Corrugated Stainless Steel Tubing (CSST) gas pipe in their home.

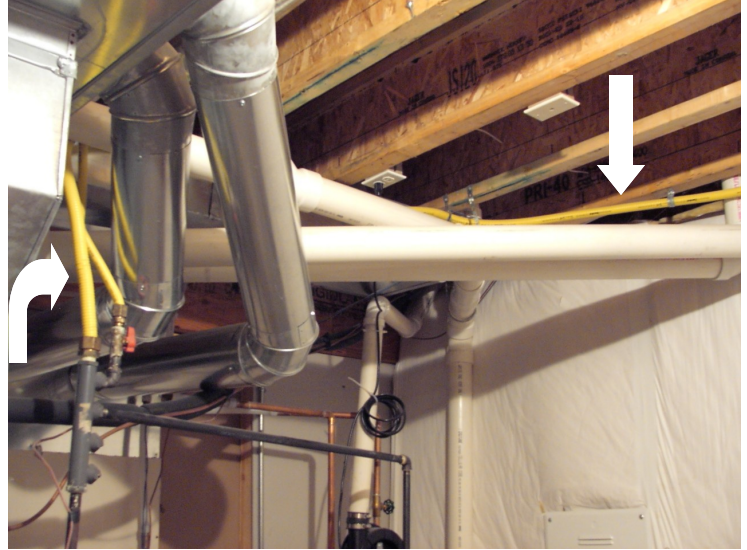
CSST pipe is a flexible, metal gas piping system used in many homes constructed or remodeled since the early 1990s. The corrugated tubing can be identified by a yellow plastic coating. The picture to the right shows what yellow CSST looks like. You commonly will see it where your water heater, furnace, or fireplace are located.

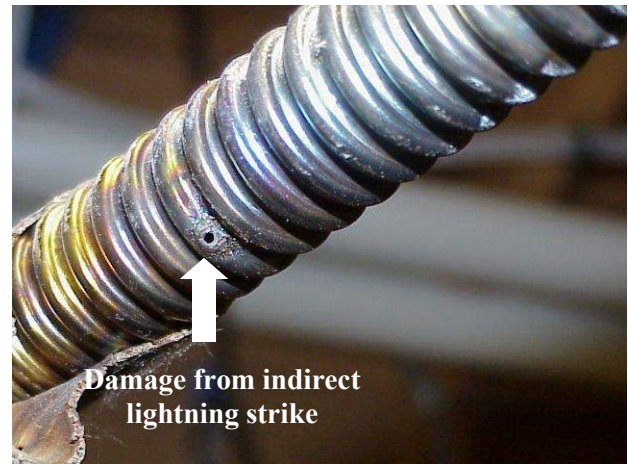
Many installations of CSST prior to 2010 do not have the appropriate bonding and grounding needed for the tubing. Proper bonding and grounding may reduce the risk of damage or fire from a lightning strike. Even a nearby lightning strike that does not strike a structure directly can cause damage to CSST tubing that is not properly bonded and grounded.

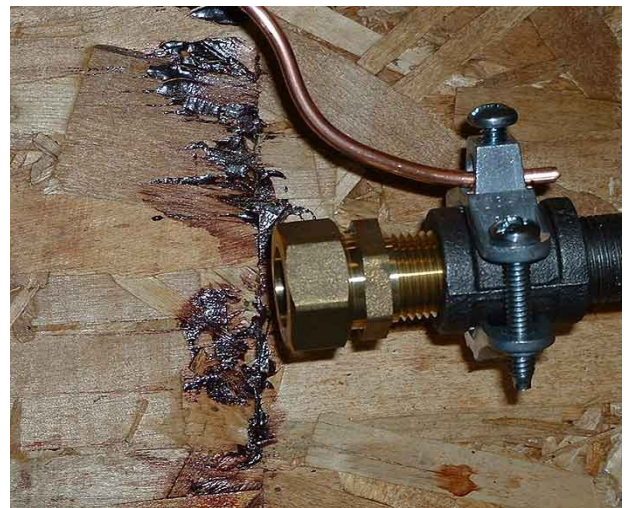
If you do not see any metal clamps or copper wire where your gas line enters your home from the outside or on any black iron pipe near CSST in your utility room, you are encouraged to contact an electrician or your home builder to assist you in determining the appropriate bonding and grounding that may be needed for the CSST in your home.
