## Important Information for Homeowners!

The Waukeee Fire Department would like to provide important information to Waukeee residents who have Corrugated Stainless Steel Tubing (CSST) gas pipe in their home.

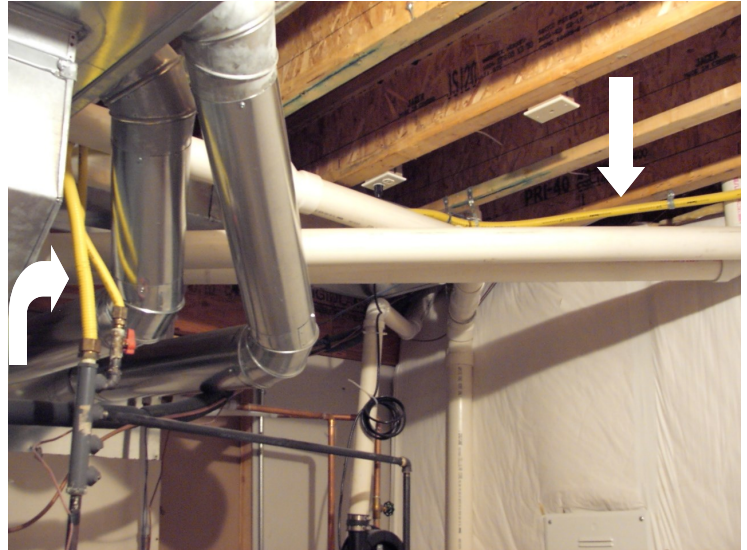
CSST pipe is a flexible, metal gas piping system used in many homes constructed or remodeled since the early 1990s. The corrugated tubing can be identified by a yellow plastic coating. The picture to the right shows what yellow CSST looks like. You commonly will see it where your water heater, furnace, or fireplace are located.

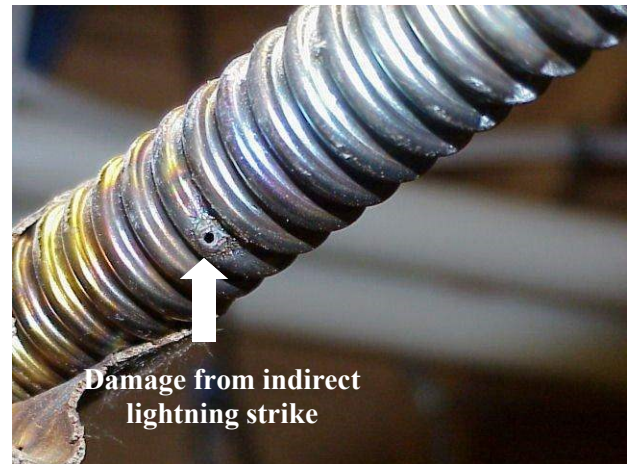
Many installations of CSST prior to 2010 do not have the appropriate bonding and grounding needed for the tubing. Proper bonding and grounding may reduce the risk of damage or fire from a lightning strike. Even a nearby lightning strike that does not strike a structure directly can cause damage to CSST tubing that is not properly bonded and grounded.

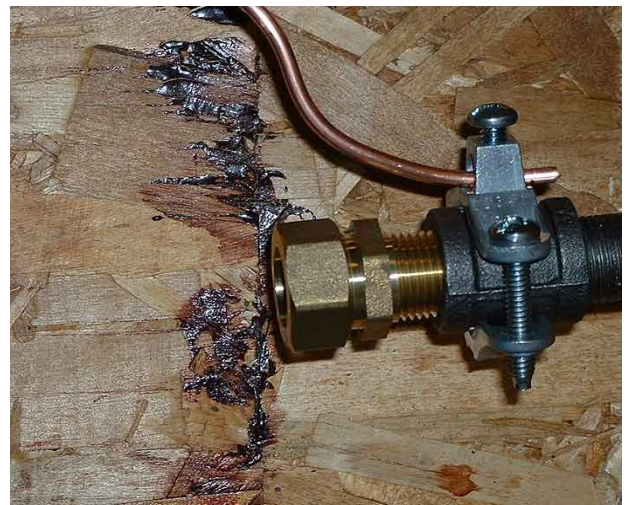
If you do not see any metal clamps or copper wire where your gas line enters your home from the outside or on any black iron pipe near CSST in your utility room, you are encouraged to contact an electrician or your home builder to assist you in determining the appropriate bonding and grounding that may be needed for the CSST in your home.
